Mid-life Condition Assessment

For Critical Oil-Immersed Power Transformers

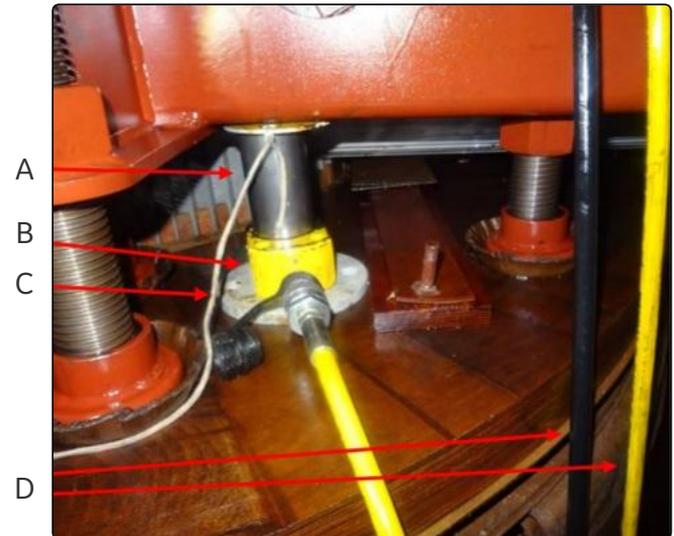
Figure 5: Example with one of the four hydraulic jacks in position between the clamping beam and the top winding platform, with load spreader to distribute the pressure. All four hydraulic lines were brought in through the HV turret.

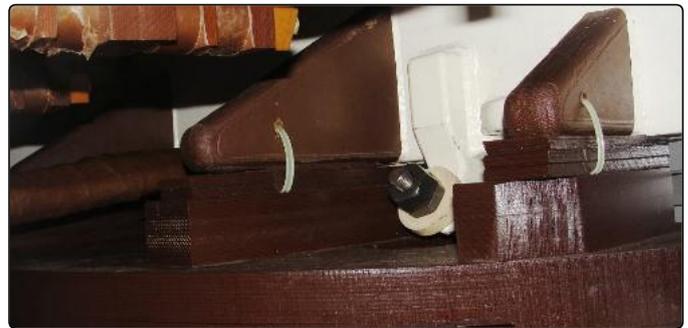
Figure 6: View of clamping brackets on LV side of one phase after the winding re-clamp. The photo shows how cable ties were used to secure blocks and shims.

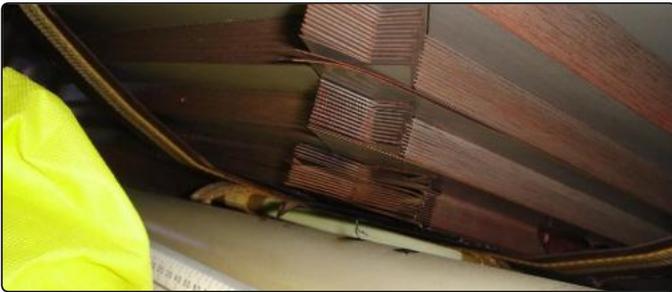
Findings: Short circuit and circulating current damages identified on core and core frame of a 19 year old large step down transformer 230 kV/10,5 kV.

Recommendation: Fault rectification with core and frame insulation and components repositioning.

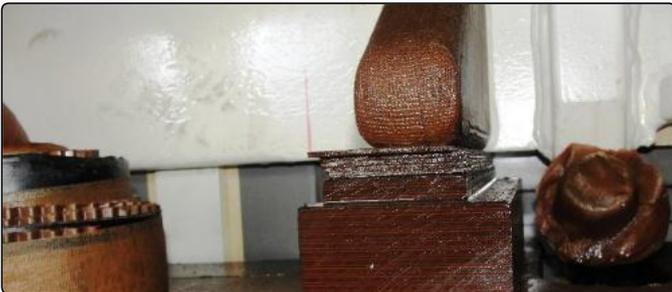
Loose clamping

Findings: The clamping on one phase was found to be loose. The group of shims and thin block was so loose that it could be pulled out by hand.

Recommendation: Winding re-clamping.

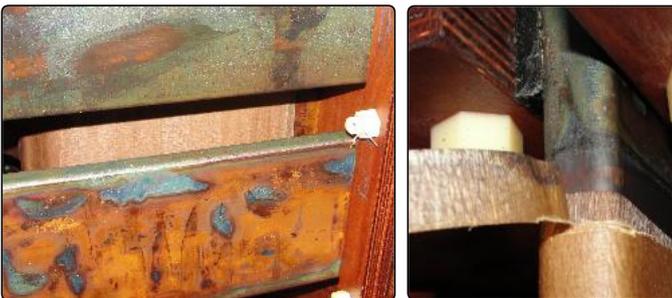
Copper sulphide formation

Findings: Copper sulphide formed on copper busbar and in the wraps of the paper insulation on copper conductors.

Recommendation: Cleaning of copper busbars and replacement of paper impacted by deposit where accessible. Rinse of the transformer active parts to eliminate residual corrosive oil, oil reclamation and chemical treatment or oil change according to the transformer history of maintenance.

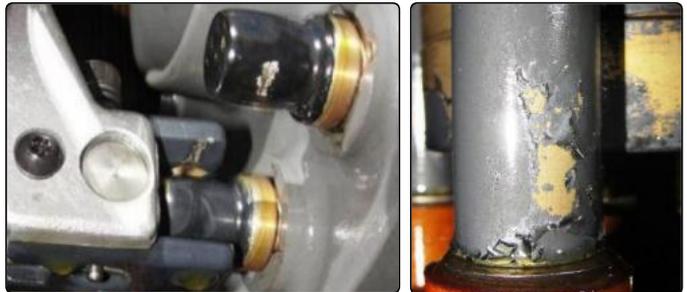
Corrosive sulphur formation

Findings: Silver sulphide on de-energized tap changer of a large 35 year old 330 kV/138 kV/11 kV auto-transformer.

Recommendation: Cleaning, treatment, passivation, change of oil reclamation process or replacement according to extent of damage and history.

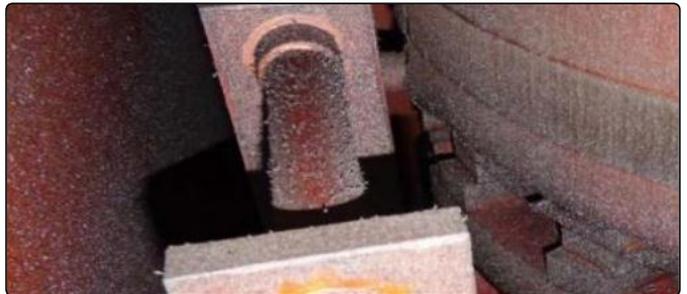
Findings: Sludge formation and aggregated particles aligned in a direction perpendicular to the surface, following the localized electrical field gradient.

Recommendation: First recommendation is for a sludge removal to mitigate winding pollution risks and to protect the dielectric strength. Second recommendation is for the amendment of the oil management strategy based on the condition assessment of the oil and insulations. Operations that could be performed according to condition, implementation constraints and local regulation include: oil replacement, oil reclamation, online or offline oil filtration.
