UR Family

Version 7.1x

Release Notes

GE Publication Number: GER-4480F
Copyright © 2019 GE Multilin Inc.

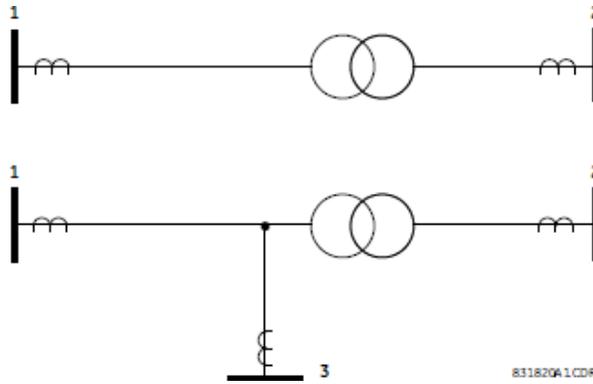
Description: Firmware version 7.10 improves the L90’s protection capabilities by enabling the L90 to fit two and three terminal line differential schemes that have a power transformer within the protection zone with no dedicated set of CTs.

Illustration of in-zone transformer for two and three terminal lines
