## UR Family

# Version 7.32

## Release Notes

GE Publication Number: GER-4709F  
Copyright © 2017 GE Multilin Inc.

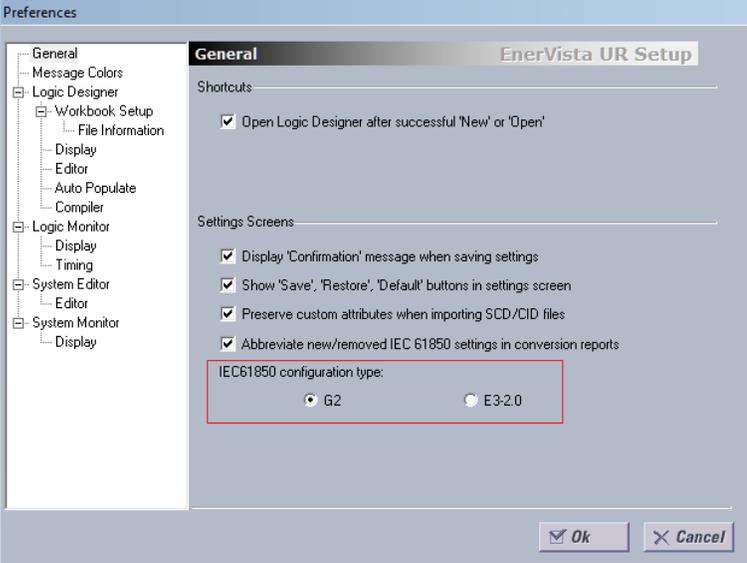
Software Exceptions	
7	<p>A setting field for selecting between G2 and E3 mode (used when creating CID setting files) was missed from the preference windows</p>
