JunglePAX – Release Notes

Firmware Package p/n 90000-01
Version: 1.16d
Release Date: July 3rd, 2020
Type of Release: Production Release

Lentronics JunglePAX

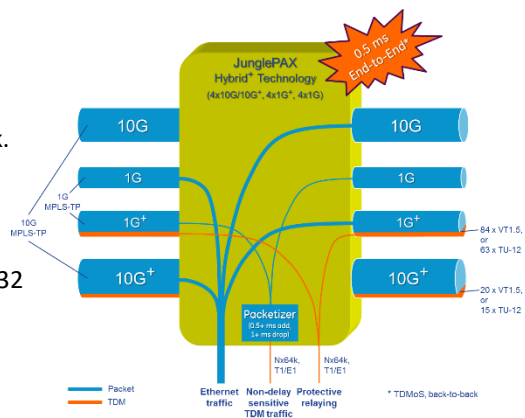
JPAX Hybrid Mode

JunglePAX Hybrid+ Technology offers the best of both worlds by preserving SONET/SDH performance in a packet-switched network. This is achieved by adding an independent SONET/SDH layer alongside the MPLS-TP layer (without impacting its capacity) over the same optical WAN link. Use of this layer is optional and is intended for TDM-based relaying applications (C37.94, RS-232 Mirrored Bit, G.703 64k etc.) that are extremely delay sensitive.
