Mid-life Condition Assessment

For Critical Oil-Immersed Power Transformers

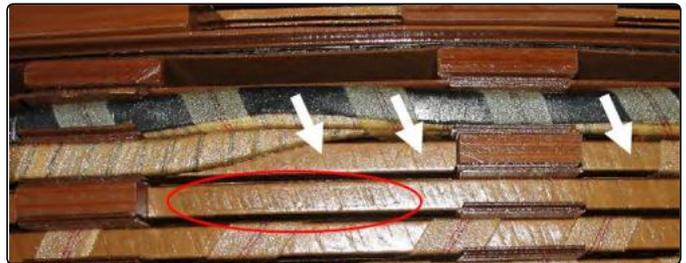
Figure 3: Paper sampling locations must be chosen according to the accessibility and rebuilt feasibility. Locations should be reasonably representative of winding temperature conditions or hot spot conditions.

Paper sampling at relevant locations (Figure 3) can complement the internal inspection.

The analysis of the Degree of Polymerization (DP) performed at the oil laboratory gives insights to evaluating the aging of the insulation, to identify any accelerated aging issue and estimate the remaining life time of the insulation for given operating conditions.

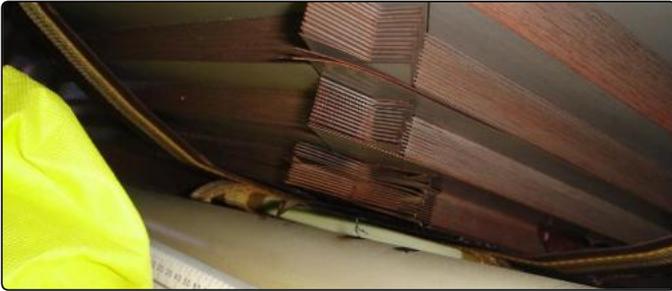
Findings: Short circuit and circulating current damages identified on core and core frame of a 19 year old large step down transformer 230 kV/10,5 kV.

Recommendation: Fault rectification with core and frame insulation and components repositioning.

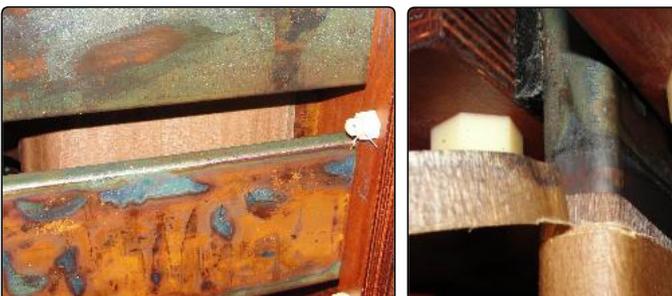
Copper sulphide formation

Findings: Copper sulphide formed on copper busbar and in the wraps of the paper insulation on copper conductors.

Recommendation: Cleaning of copper busbars and replacement of paper impacted by deposit where accessible. Rinse of the transformer active parts to eliminate residual corrosive oil, oil reclamation and chemical treatment or oil change according to the transformer history of maintenance.

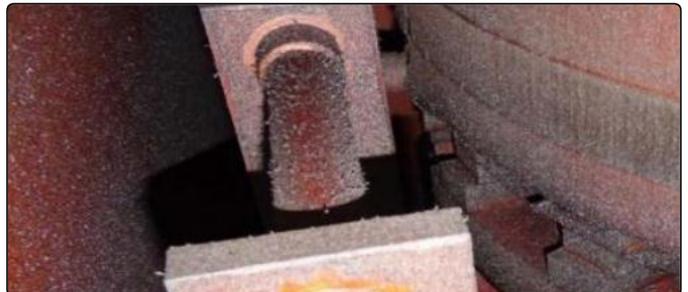
Findings: Sludge formation and aggregated particles aligned in a direction perpendicular to the surface, following the localized electrical field gradient.

Recommendation: First recommendation is for a sludge removal to mitigate winding pollution risks and to protect the dielectric strength. Second recommendation is for the amendment of the oil management strategy based on the condition assessment of the oil and insulations. Operations that could be performed according to condition, implementation constraints and local regulation include: oil replacement, oil reclamation, online or offline oil filtration.
