UR Family

Version 5.4x

Release Notes

GE Publication Number: GER-4654A
Copyright © 2017 GE Multilin Inc.

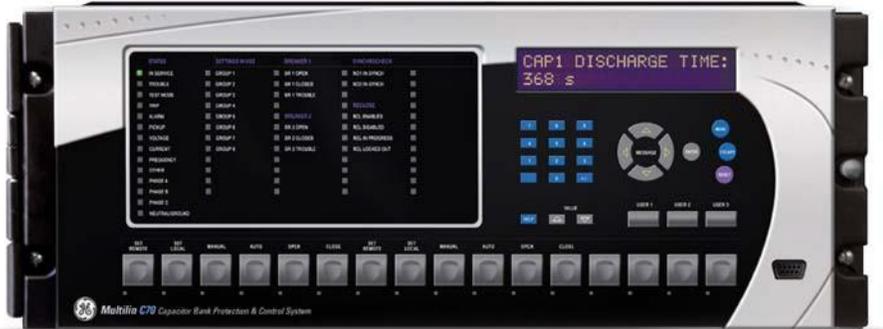
N Enhanced Horizontal Front Panel

The UR Horizontal Front Panel has been enhanced to provide expanded functionality and increased visualization to power system events. This enhanced front panel can be purchased on new units ordered from the factory or as an upgrade kit for relays currently installed in the field. The enhanced front panel is completely backwards compatible with older units and firmware versions and can be installed without removing the relay from service. Enhancements to the UR horizontal Front Panel include:

- **Larger Display** – The Enhanced Front Panel has a new LCD display that is brighter and is 2.5 times larger than the basic Front Panel.
- **Lockable RS232 port** – The new lockable RS232 port ensures that the communications cable is secure during configuration and relay interrogation.
- **Four Additional User-Programmable pushbuttons** – Four additional User-Programmable Pushbuttons have been added to the pushbutton option of the Enhanced Front Panel. These fully

configurable User-Programmable Pushbuttons replace the 4 blue User Buttons that were previously offered on Front Panels ordered with the Pushbutton option.
